RAY COUNTY DAM NO. A-1

RAY COUNTY, MISSOURI

MISSOURI INVENTORY NO. 11084

PHASE I INSPECTION REPORT
NATIONAL DAM SAFETY PROGRAM

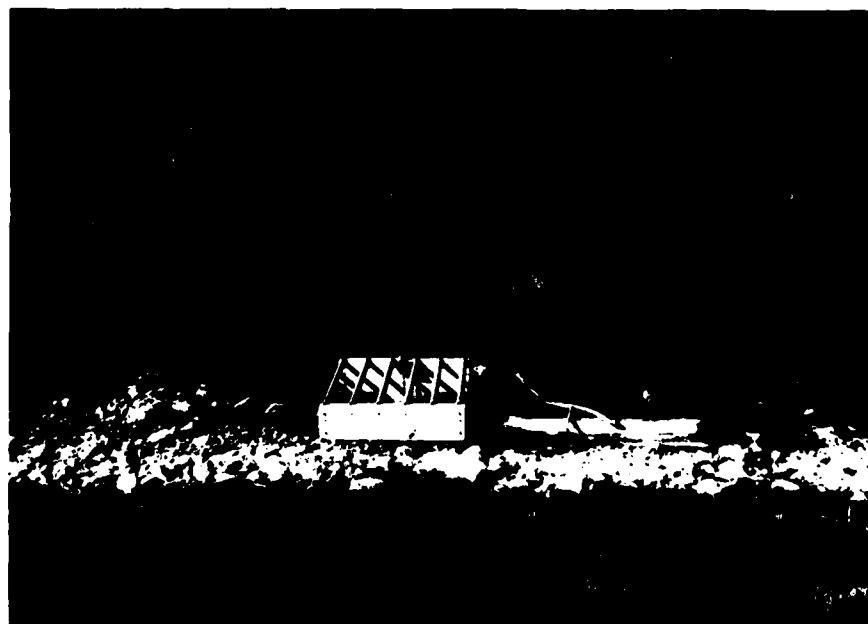
The principal spillway consisting of a drop inlet with trash rack appears to be in good condition.

The slide gate within the drop inlet was open approximately 4 inches at the time of inspection. The gate was in good operating condition at the time of inspection.

PHOTO 6: PRINCIPAL SPILLWAY
